| <p><b>SOLUTIONS DELIVERED</b></p> | | <p><b>APPLICATION INVESTIGATION:</b></p> <p><i>Project Description:</i> Reflective Sign Coating<br/> <i>Customer:</i> Transurban<br/> <i>Location:</i> Melbourne<br/> <i>Date:</i> May 2018<br/> <i>Product:</i> X-Restore</p> |

**Project Overview** Transurban have a significant number of reflective signs that degrade with time due to UV exposure or their life is shortened by environmental conditions, not excluding graffiti. A number of their signs also use Red lettering / markings which are extremely susceptible to UV degradation. xGen X-Restore was applied with the intention of providing:

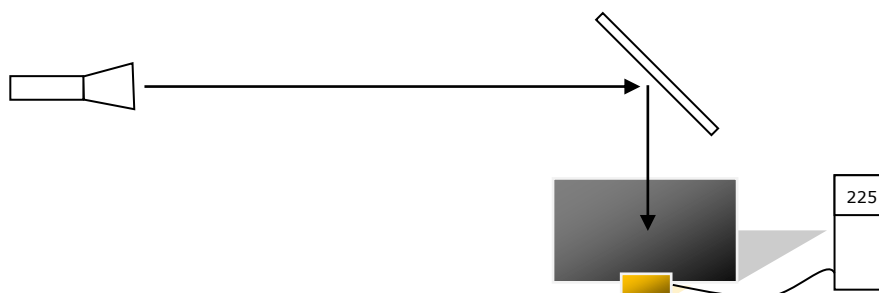
**Test Rig Configuration** A focused light beam was reflected off the sign through a hole in the top of the box directly onto the light meter sensor and the reading recorded.

**Test Method** Prior to X-Restore being applied a test rig was set up to measure the light intensity of the light reflected off the sign at approximately 45 degrees angle to the surface of the sign.

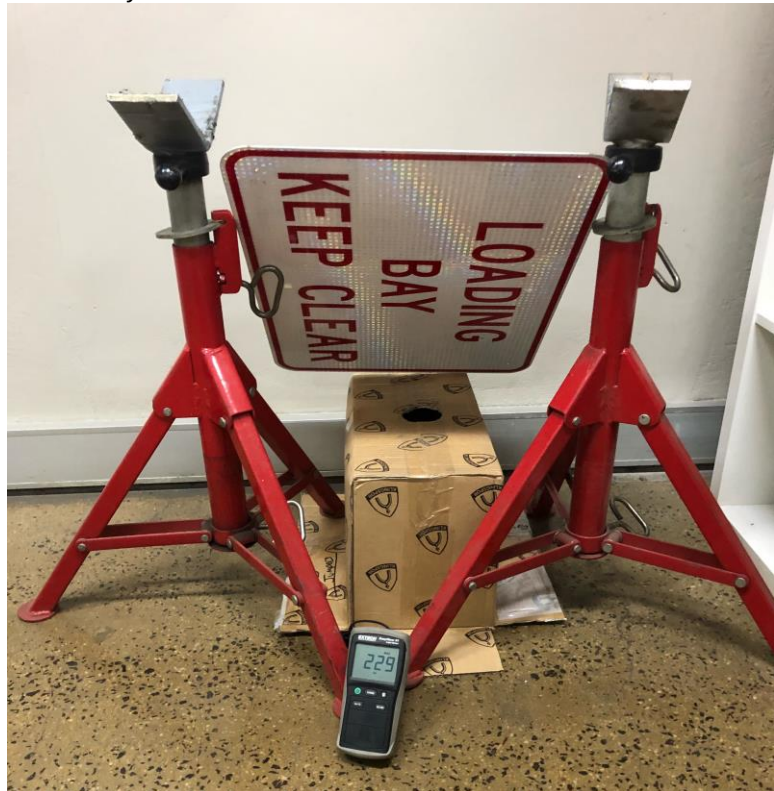
Test 1 - Uncoated @ 7:15am 30<sup>th</sup> May 2018

| Test | Status | Light Level | | Result | Comments |
|---|---|---|---|---|---|
| 1 | Prior to Coating | 229 | LUX | Reference | |

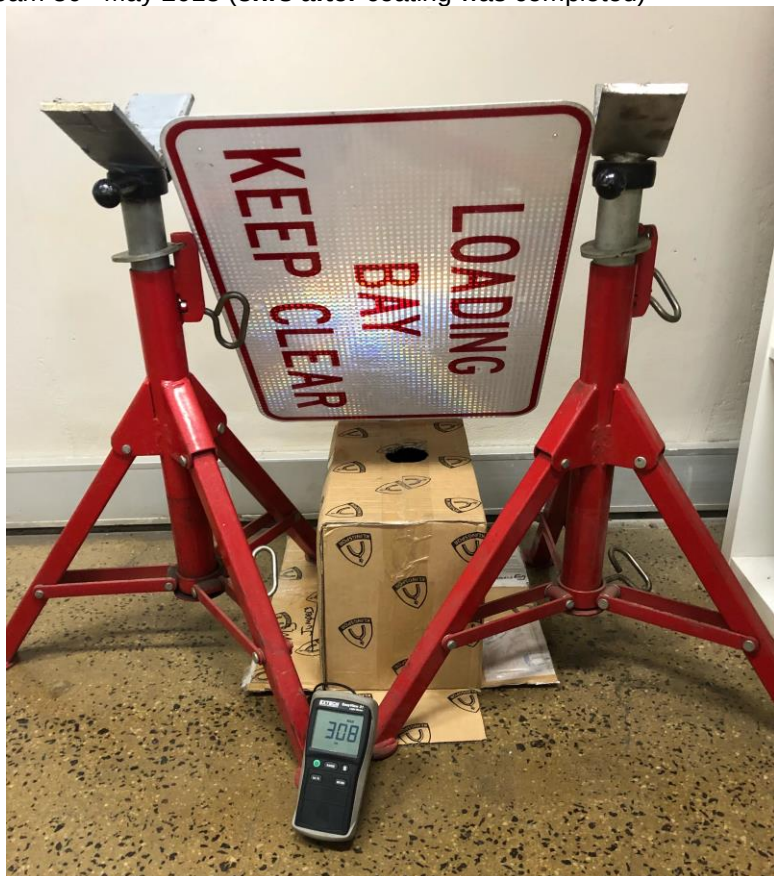
Test 2 – Coated @ 11:15am 30<sup>th</sup> May 2018 (3hrs after coating was completed)

| Test | Status | Light Level | | Result | Comments |
|---|---|---|---|---|---|
| 2 | 3 Hrs after Coating | 308 | LUX | 34.5% Increase | Surface good to touch, felt soft |

You will note in test 2 and 3 the sign has a greater reflective intensity. The glow is the reflection of light from the tape on the cardboard box just from room lighting.

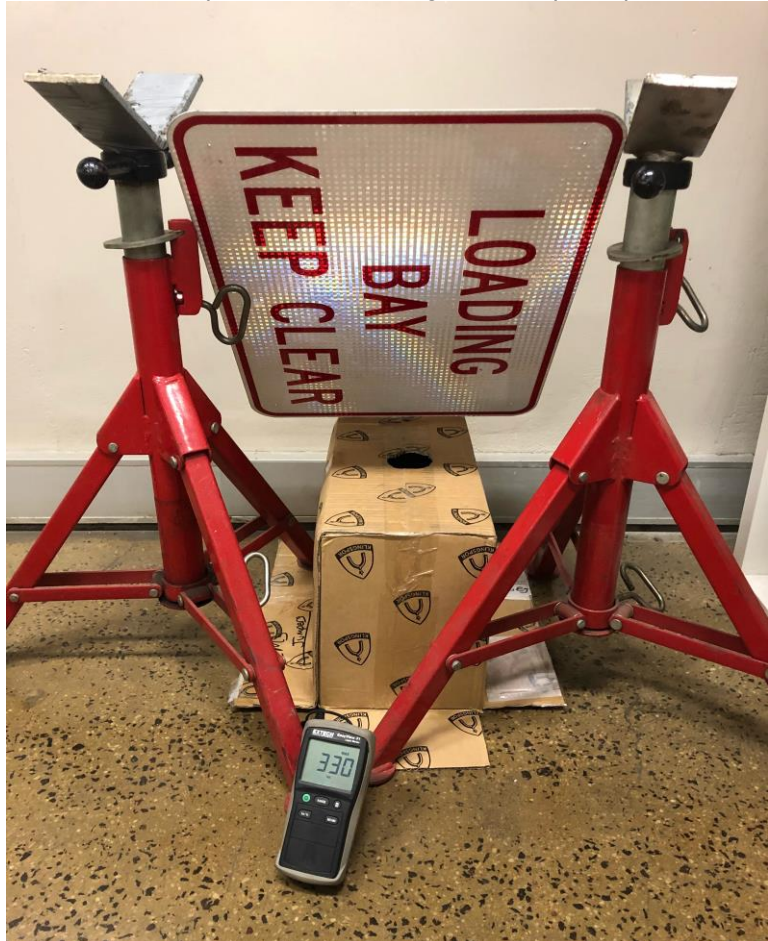
Test 3 – Coated @ 7:15am 1<sup>st</sup> June 2018 (23hrs after coating was completed)

| Test | Status | Light Level | | Result | Comments |
|---|---|---|---|---|---|
| 3 | 23 hrs after Coating | 330 | LUX | 44.1% Increase | Surface good to touch, felt hard |

**Comments** The initial expectation of the trial was a slight reduction in the reflectivity. What was experienced, was an un-expected gain of 44.1%. What we believe has occurred, is a more concentrated (less diffused) beam of light reflecting off the surface. All environmental conditions were maintained to ensure accurate correlation between the results could be established.
